# Video inspection replaces track patrolling

**TRACK SAFETY** Video equipment has transformed track inspection in the Netherlands where on-track patrolling is no longer permitted. Eurailscout helped to pioneer the video inspection trains which make 900 trips a year to inspect switches and crossings.

**Roland Bongenaar**  
Project Manager, Eurailscout

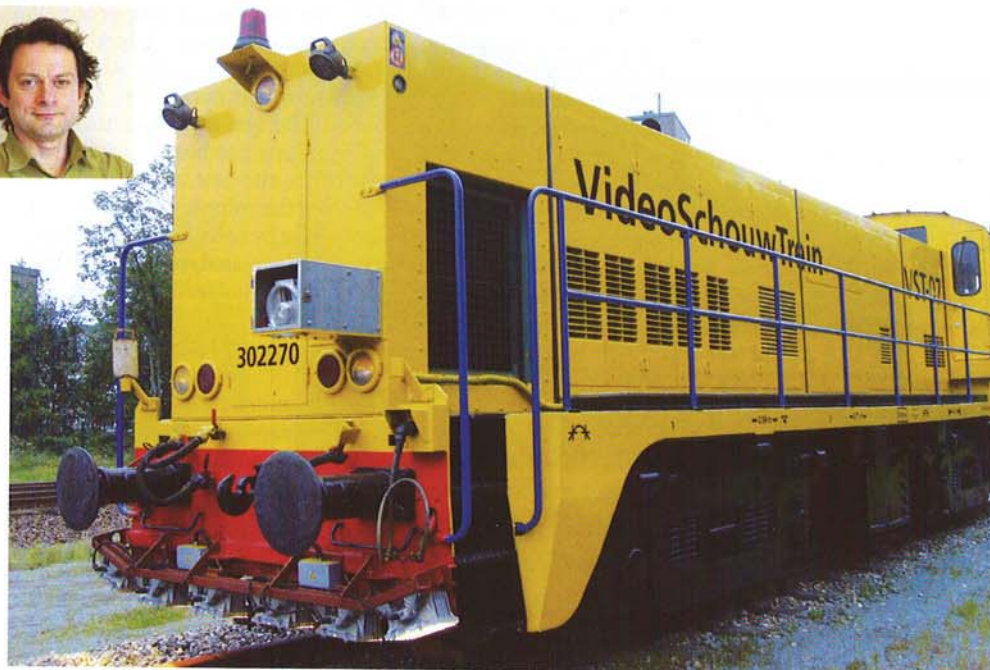
ProRail has access to four video inspection trains, each equipped with eight cameras.

Eurailscout's video inspection trains comprise a locomotive converted to a recording vehicle and equipped with eight cameras:

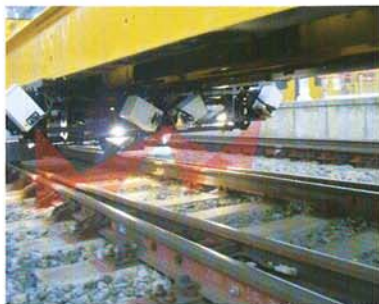
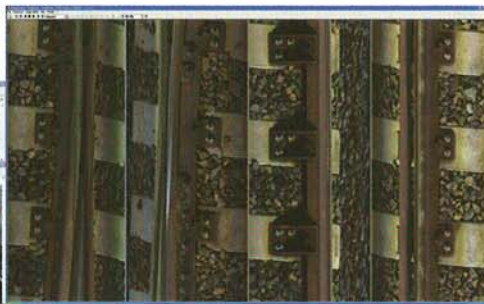
Each recording train has four colour linescan cameras (above). The high-resolution video footage can be viewed either in colour or in black and white.

- pointing forwards, the other backwards; the cameras are installed at a height of 1.7 m to simulate the perspective of a walking inspection; the colour images have a resolution of 1 392 x 1 032 pixels;
- four colour linescan cameras with a resolution of 1 mm x 1 mm and a range of 800 mm; these record the inner and outer edges of the rails;
- two black and white linescan cameras with a resolution of 1 mm x 1 mm and a range of 1.5 m per camera; together they show the full permanent way.
